**TEST REPORT**  
**Reliability of a 500 kWh ZBB Battery**  
**Energy Storage System**  
**California Energy Commission**  
**PG&E Substation**

**November 9, 2007**

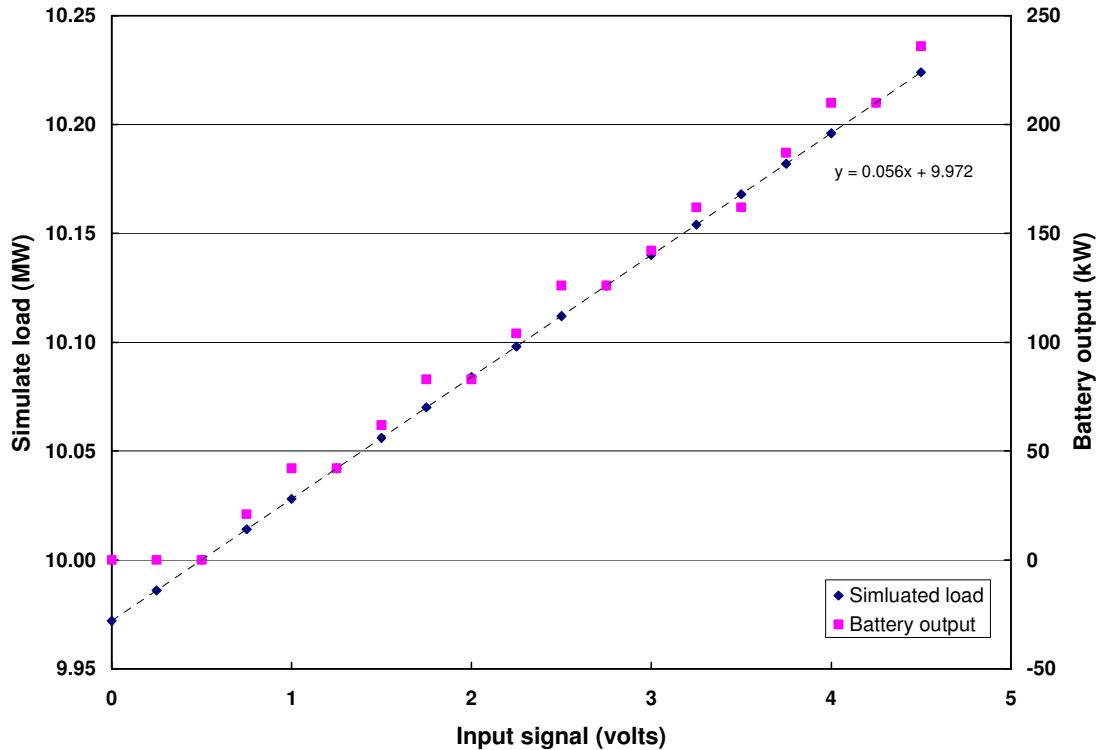
The limits of the output signal were set up so that 9.97MW produces a 0 volt signal and 10.25MW produces a 5 volt signal. The test plan intended for the signal to ask for discharges up to 320 kW and the battery should deliver only its maximum output of 250 kW. However, the way the test was actually set up, the signal only asked for a maximum discharge of 250 kW. The battery would have given the same output but the issue is that the signal generator set the maximum discharge value rather than the battery seeing a higher signal and providing 250 kW discharge. The signal should have been set up so that 5 volts = 10.32 MW, not 10.25MW. This was a miscommunication in setting up the parameters of the test and not a shortcoming of the battery system. Separate

Figure 3. Load following calibration curve

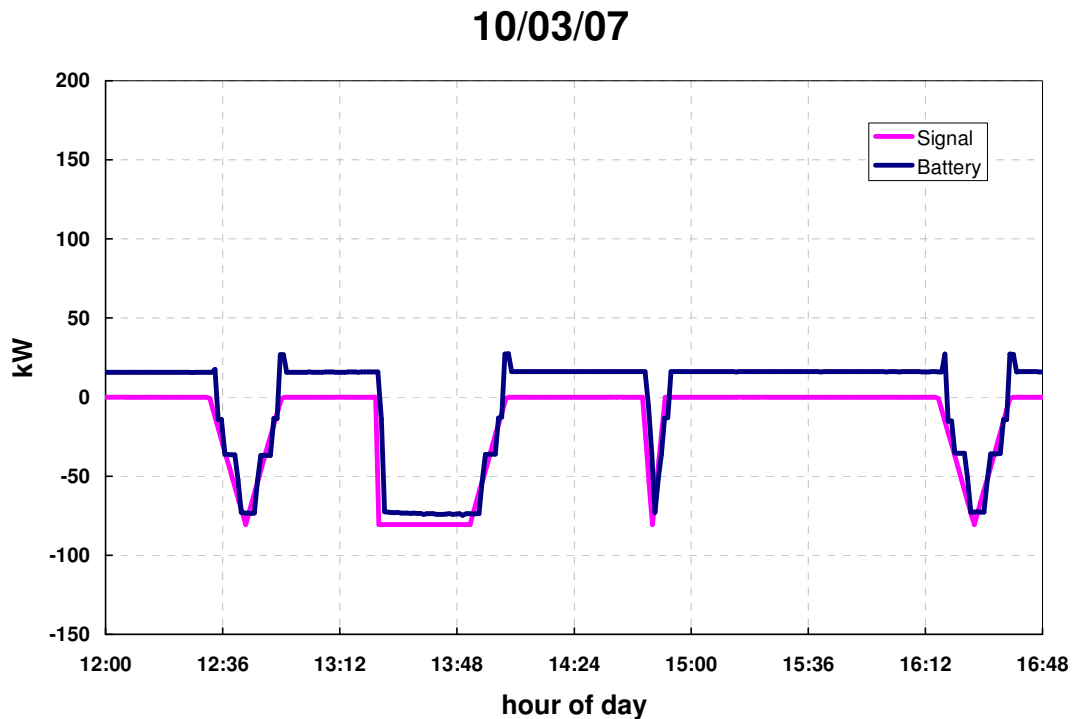
On 10/03/07 the battery performed multiple load following discharges from multiple days (total of 4) as shown in Figure 8. This was done to complete all the discharges for the 40 days in a fewer number of days.

**Figure 8. Multiple load following discharge during a single day**

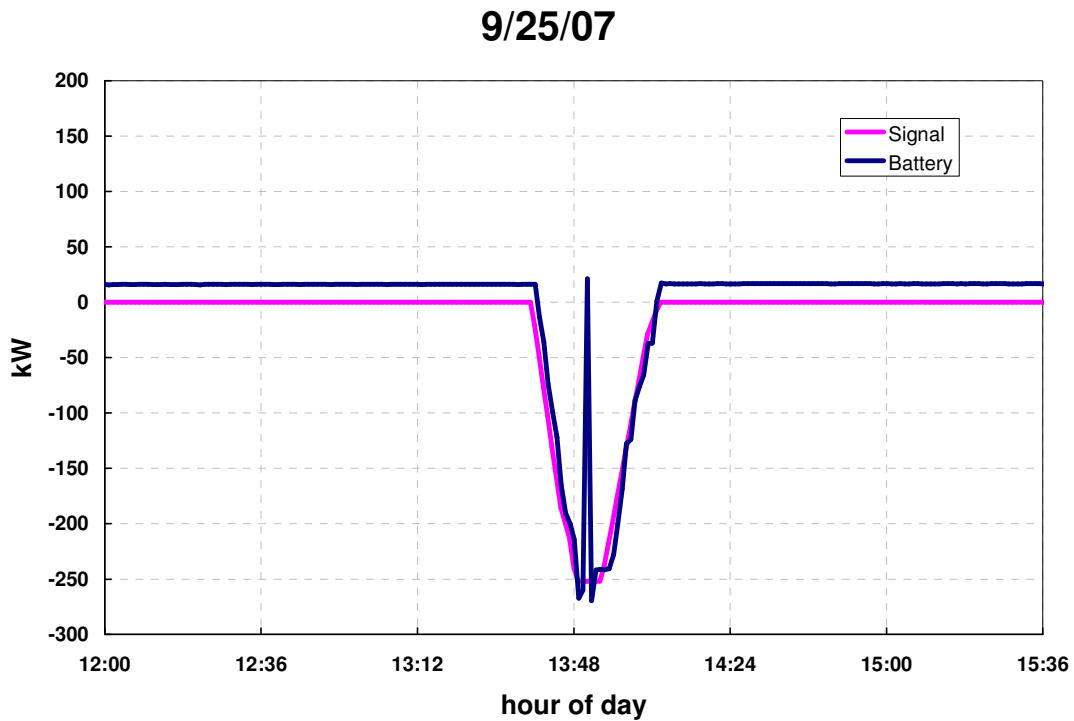
The load following discharge on 9/25 was temporarily interrupted due to one of the modules being automatically taken out of the string. This 1-minute interruption is shown in Figure 9. This was caused by the incomplete discharge of one battery module from the previous day, due to an indication that one of the motor drives was operating improperly. The module was automatically bypassed and the remaining modules completed the remainder of the load following discharge. This unexpected event shows that the battery system is capable of detecting potential problems on individual modules, which can then be automatically bypassed and disconnected with only a short interruption in energy supply.

**Figure 9. Interruption during load following discharge.**

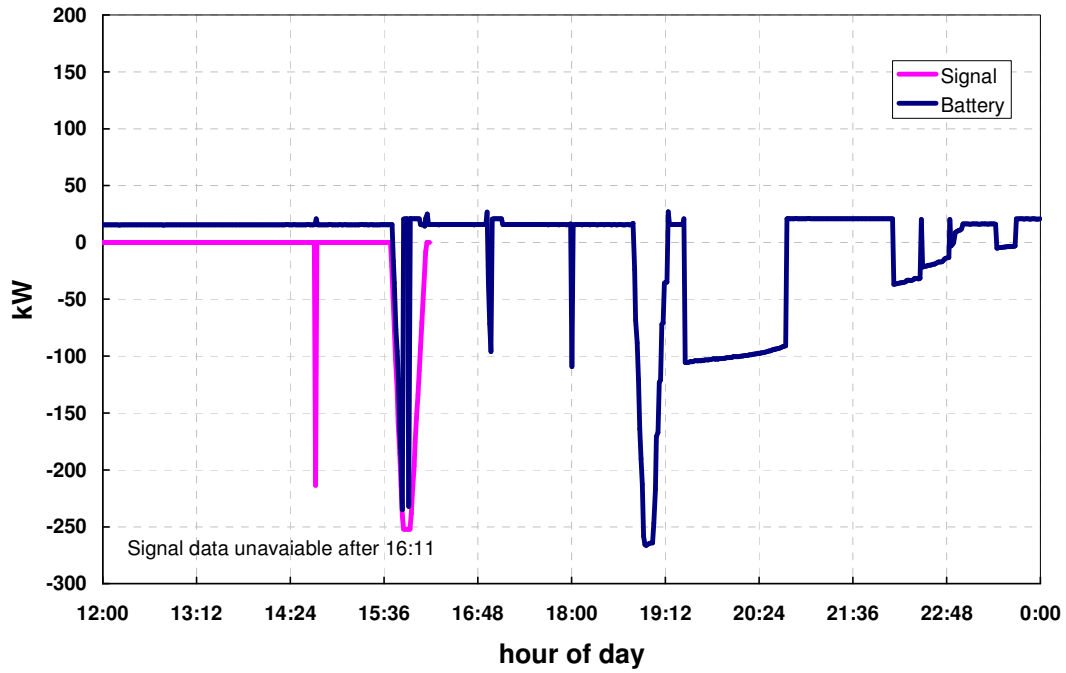
10/10/07

During the cycle on 10/10, the battery was following the generated signal until the load reached about 230 kW when a contactor malfunctioned. ZBB had personnel on-site (along with representatives from DUA and EPRI-PEAC) who attempted to reset the condition. After several unsuccessful resets, it was established that the contactors on module #2 was not operating properly and they were replaced. The system operated properly after replacing the contactors, and successfully completed the load following profile. The initial contactor malfunction, manual resets and load following discharge can be seen in Figure 10.

**Figure 10. Load following discharge following contactor replacement.**

Following completion of the reliability test period, the contactors from this module were inspected and ZBB found that they were installed improperly (a stainless steel lock washer was installed in the current carrying path). This caused the contactor to overheat and ultimately fail during the test. The installation procedure for installing the contactors has been updated and training has been implemented to prevent this type of failure from occurring in the future.

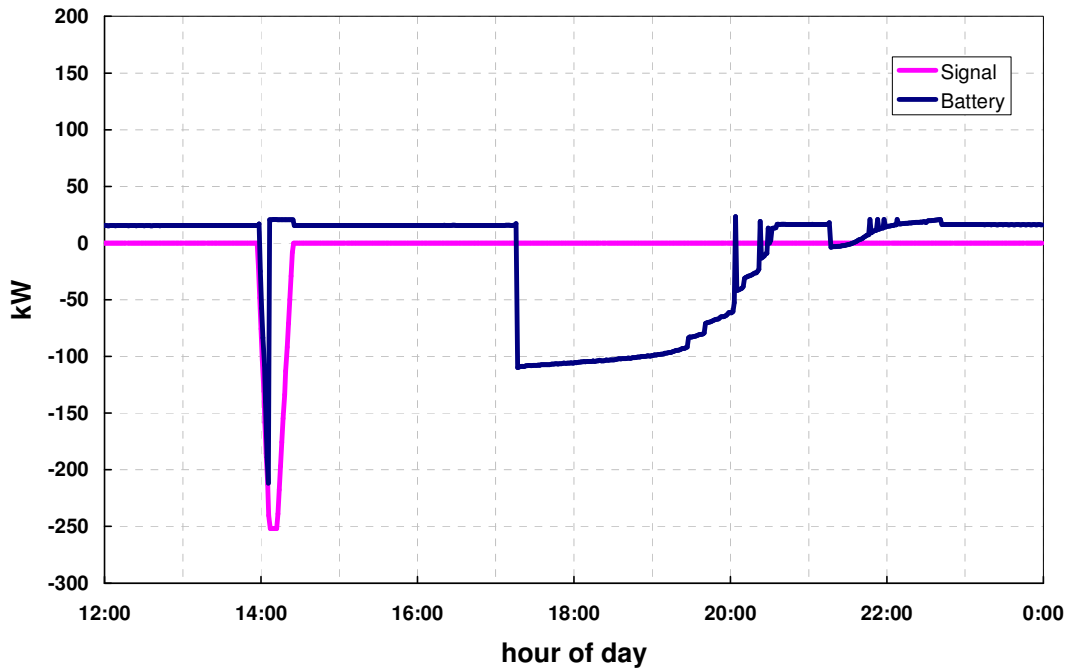
10/09/07

After reviewing the data, we determined that a similar condition had also occurred on the previous day (10/09) as shown in Figure 11.

**Figure 11. Load following interruption due to contactor malfunction.**

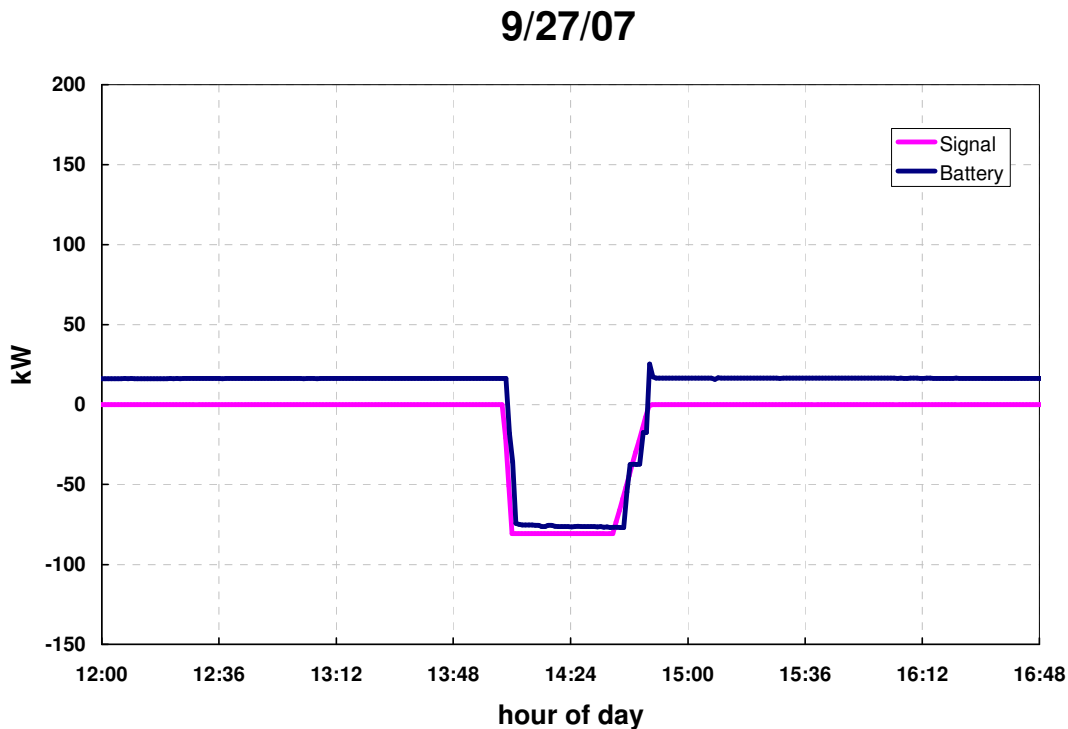
The battery control software was set up to discharge in 20 kW increments rather than using a continuous range. Because of this, the battery discharged more than the required kW during some of the profiles (i.e., the battery discharged 260 kW for a 250 kW discharge signal). Also, the battery was found to deliver less than the desired output on a number of cycles, primarily during the 80 kW discharges as shown in Figure 12.

**Figure 12. Variation between discharge signal and battery output.**

The most likely reason for the discrepancy is the calibration of the battery output to the generated signal. The battery discharge should be recalibrated based on the actual battery output during the load following discharge tests.

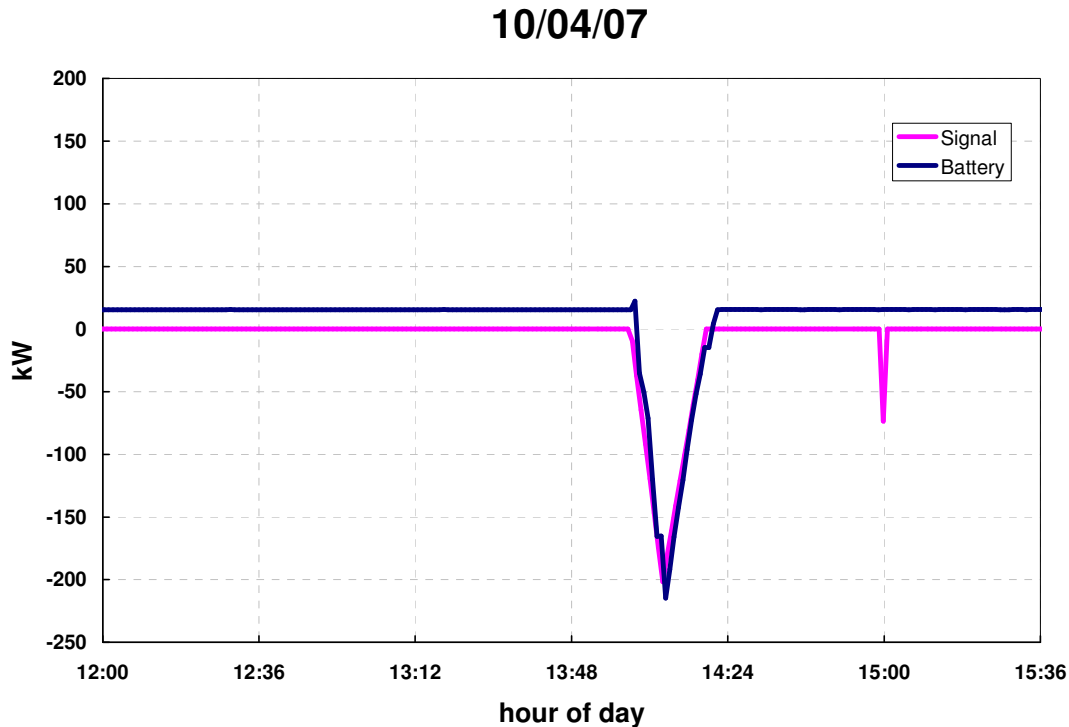
This is what happened on the two days in question; the simulator produced a short 1 minute signal while the timer was being reset, but the battery didn't react to this signal because it had been taken out of the automatic mode. The signal data shows the occurrence of a peak but the battery didn't react to the peak as shown in Figure 13.

**Figure 13. Signal generated while advancing the simulator clock.**
